Manhole Inspection Summary

Manhole # S41M__001MH

Insp Date: **11/4/08 12:36 PM**

Location Address: **albemarle st**

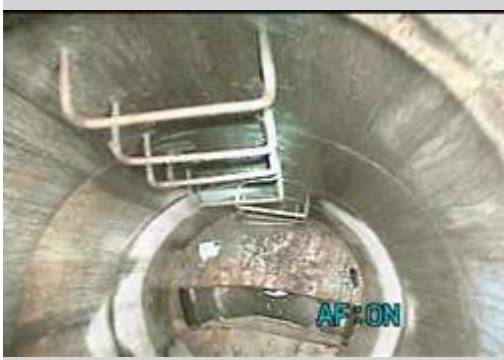
Defect 1

Infiltration: ☐ None ☒ Joint ☐ Cracks ☐ Mortar ☐ Roots ☐ Wall

Steps Count: **10** Missing: **0** ☒ Corroded

cor. steps, infiltration @ chimney joint

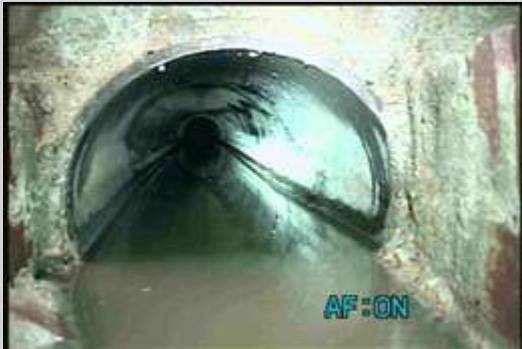
12 O'Clock Outflow

12 in. Circular Gravity Sewer
Pipe Out @ 12 O'Clock

Pipe Material: **Clay** ☐ Pipe Lined

Invert Depth: **12.75** (ft.) Flow Characteristics: **None**

Infiltration: **None** Pipe Seal Cond: **Unknown**

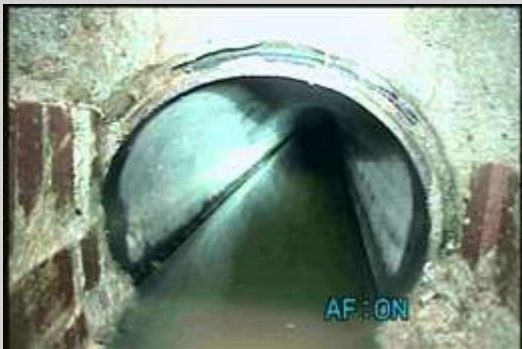
6 O'Clock Inflow

12 in. Circular Gravity Sewer
Pipe In @ 6 O'Clock

Pipe Material: **Clay** ☐ Pipe Lined

Invert Depth: **12.66** (ft.) Flow Characteristics: **None**

Infiltration: **None** Pipe Seal Cond: **Unknown**
